Infrared Thermography for CMU grouting

Inspection Masters
Infrared Division
www.inspectmasters.com

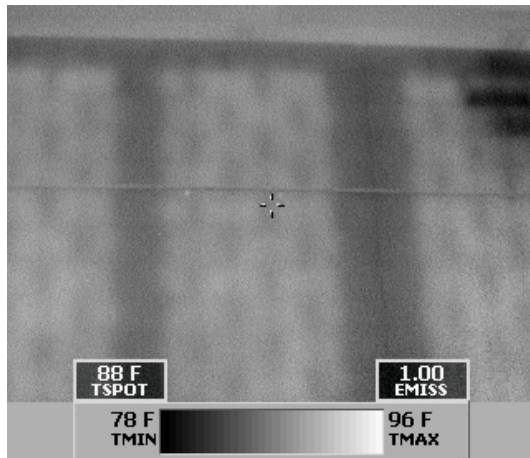
Vertical grout columns @ 40" O.C., top bond beam & double column at wall joint.

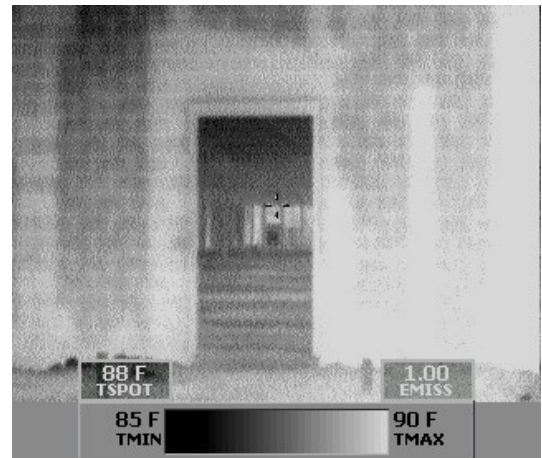
View of incomplete grouting around door jamb.
